## GRAHAMVILLE RESERVOIR DAM

NDI No. PA 00020  
PennDER No. 25-2

### PHASE I INSPECTION REPORT NATIONAL DAM INSPECTION PROGRAM

Grahamville Reservoir Dam, Erie County, Pennsylvania  
NDI No. 00020, PennDER No. 25-2  
Sixteen Mile Creek  
Inspected 16 November 1978 and 5 June 1979

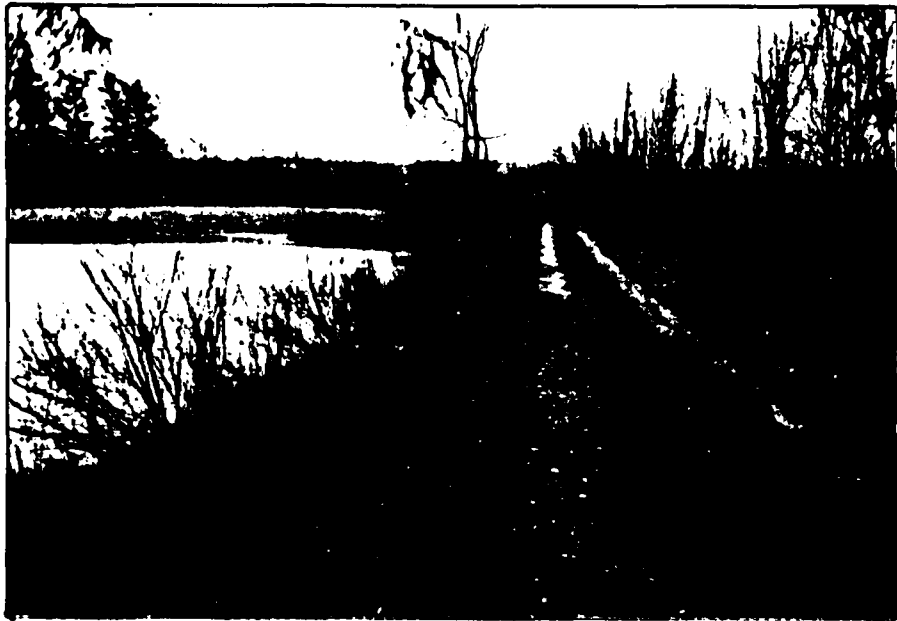
- b. Dam - Both the upstream and downstream faces of the embankment are covered with high grasses, bushes, and small trees. The upstream face has a 3 to 4 foot, near vertical drop-off at the normal pool elevation due to erosion of the embankment. Erosion was also noted approximately 200 feet from the right abutment on the downstream face. Some seepage was noted at the right abutment on the downstream side; however, due to the dense vegetative growth, an accurate assessment of the severity of the seepage could not be made, although no signs of piping were evident. Two large ruts have formed across the crest of the embankment due to vehicular traffic.

**PHOTO 4. Main Embankment from Right Abutment  
(Note Ruts and Standing Water on Crest)**

- 4) Regrade and reseed the large ruts along the crest with an appropriate mixture to prevent erosion.
- 5) Repair the concrete on the outside of the gate valve house. Also, repair the head wall for the two 12 inch outlet pipes.
